Final Photo Documentation Update for
Proposition 13
Grant Agreement No. 04-067-559-0
San Diego Region
Woodside Avenue Extended Detention Basin

**Final Photo Documentation Update
For
Proposition 13
Grant Agreement No. 04-067-559-0
San Diego Region
Woodside Avenue Extended Detention Basin**

**Weston Solutions, Inc.
2433 Impala Drive
Carlsbad, California 92008**

July 2006

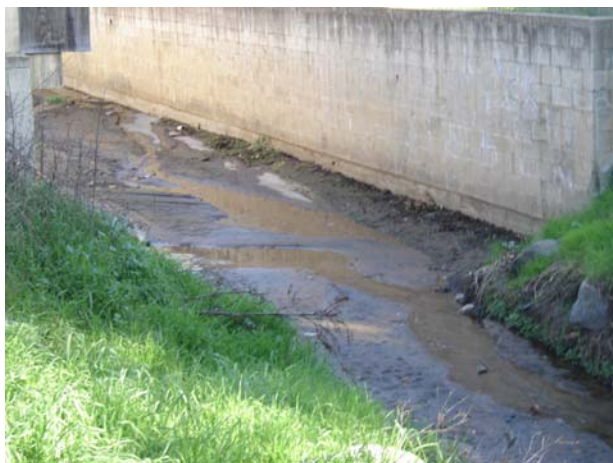
During the initial site reconnaissance the primary influent channel (identified as influent No. 1) appeared clean of debris and sediment. However, it was later determined that the channel had recently been cleaned. Following construction of the EDB during the initial attempt to install monitoring equipment, problems were encountered due to heavy sediment build up, heavy vegetative growth, and rip-rap in the basin holding water in the concrete channel. The channel was cleaned and rip-rap lowered slightly to allow for installation of monitoring equipment. In order to compensate for these obstacles and obtain accurate flow measurements it became necessary to restrict influent water flow by use of sand bags. Pictures below document this process over time. Note the re-growth already occurring in the final picture.

Primary Influent, Initial Site Reconnaissance

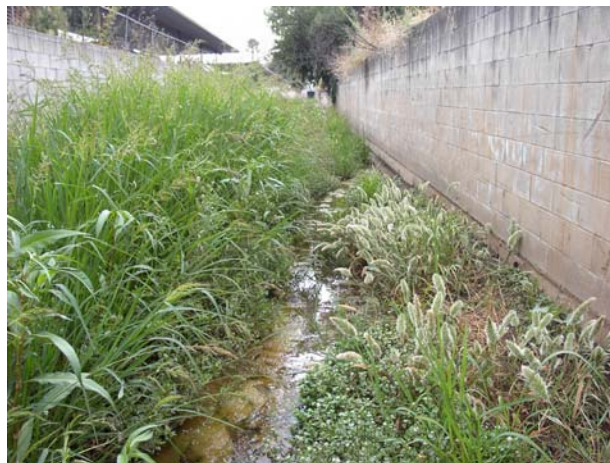
Primary Influent, Initial Attempt to Install

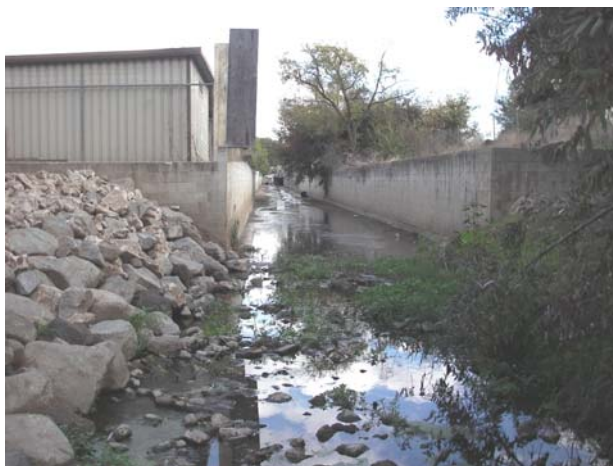
Primary Influent, After Sediment Removal

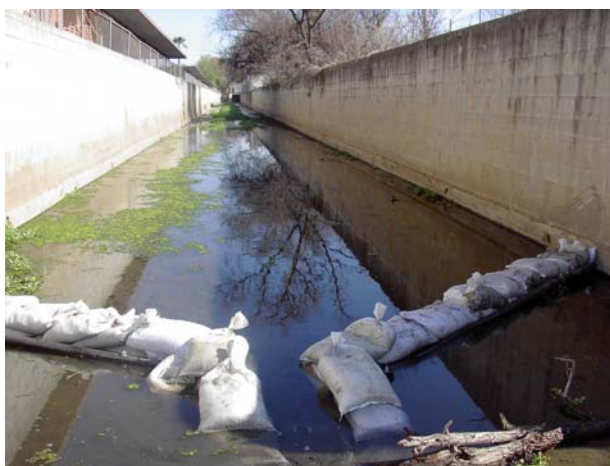
Primary Influent, After Installation

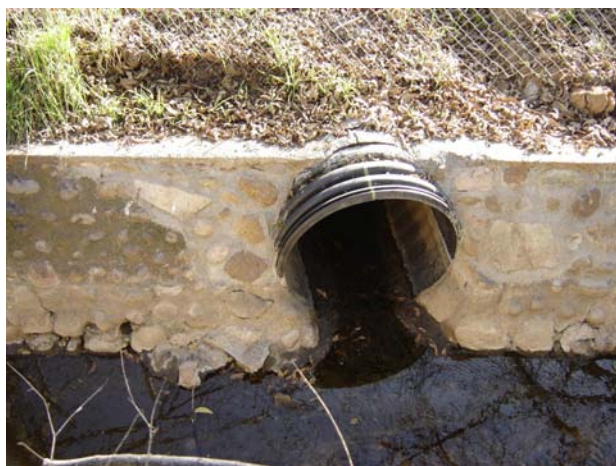
During the initial site reconnaissance the secondary influent pipe (influent No. 2) appeared clean of debris and sediment. However, following construction of the EDB during the initial attempt to install monitoring equipment, problems were encountered due to heavy sediment build up, and rip-rap in the basin holding water in the influent pipe. The rip-rap was lowered slightly to allow for better drainage. However, once the pipe was inspected for equipment installation it was discovered that the bottom section of this pipe had very little slope and sediment build up may still be a concern. In order to compensate for these obstacles and obtain accurate flow measurements it was necessary to move the monitoring equipment further up the pipe than anticipated to an area of sufficient slope. This resulted in one small influent pipe from a very limited drainage area that will not be represented in flow measurements and analytical parameters. Pictures below document this process over time.

Secondary Influent, Initial Site Reconnaissance

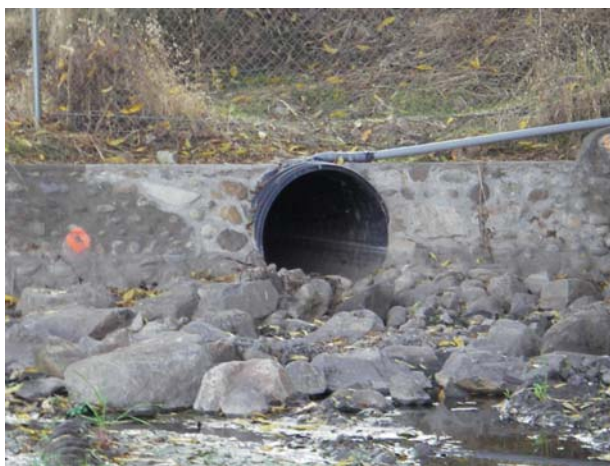
Secondary Influent, Initial Installation Attempt

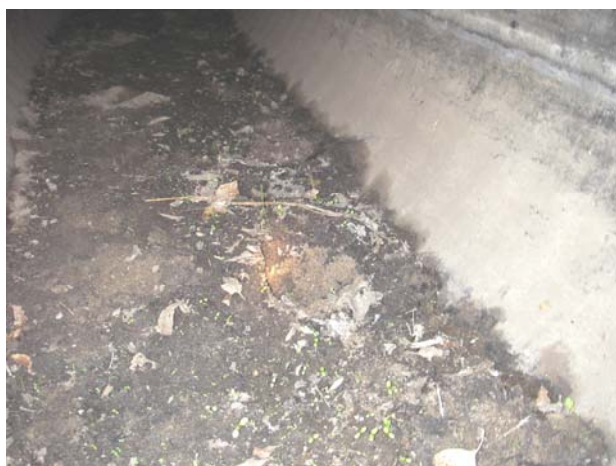
Secondary Influent, Sediment Build Up

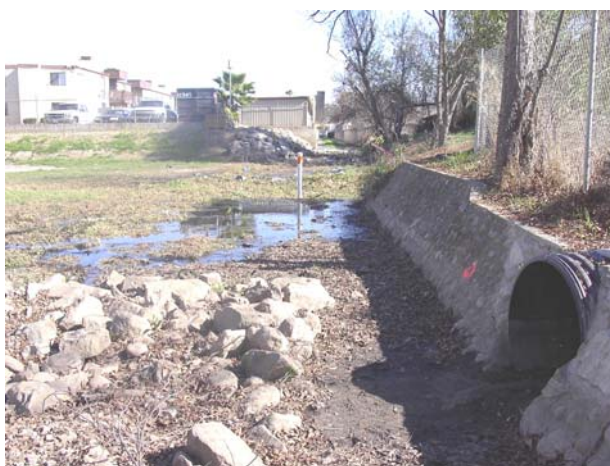
Secondary Influent, After Rip-Rap Lowering

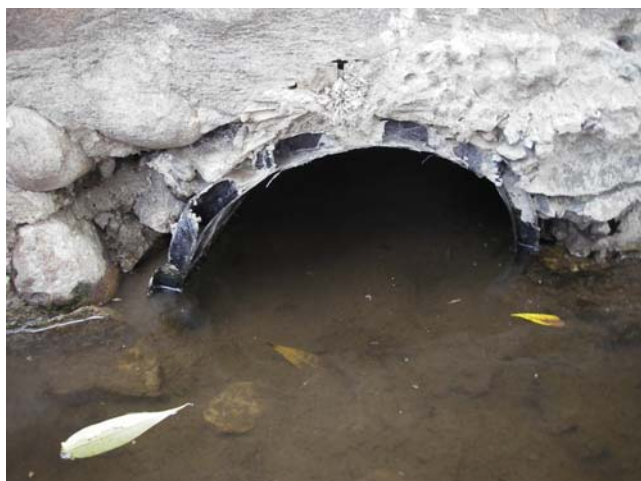
Following construction during the initial attempt to install monitoring equipment in the 12" effluent pipe (effluent No. 1) it was observed that water pooled outside of the EDB in the spillway. This resulted in low velocity flows and sediment buildup in the effluent pipe. Following meetings with County of San Diego personnel and Rick Engineering, the effluent structure was altered so flows did not pool in the spillway and reduce velocity resulting in sediment buildup. Additionally an 18" emergency bypass pipe was added to the effluent structure. It has been observed that leaves and other organic debris accumulate against the effluent grate which restricts outflow and raises the water level in the EDB. Additionally, following construction of the modifications the emergency bypass was inadvertently left open. Flows through this bypass are not captured by monitoring equipment so the bypass was then closed so that dry and wet weather flows through the EDB could be characterized and assessed. Pictures below document this process over time.

Effluent, Sediment and Low Velocity

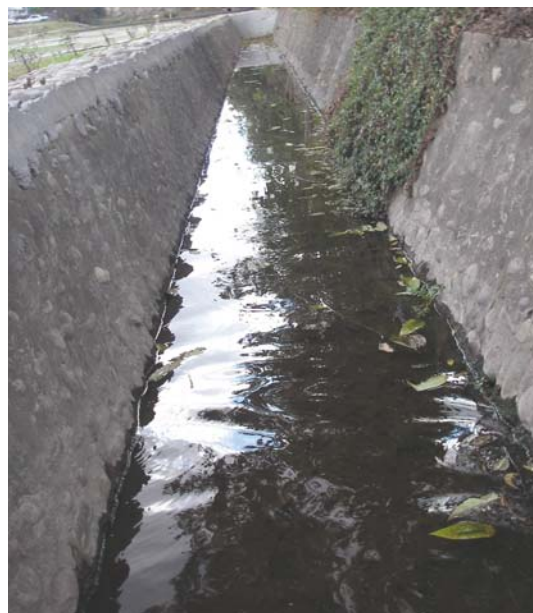
Effluent, Pooled Water in Spillway

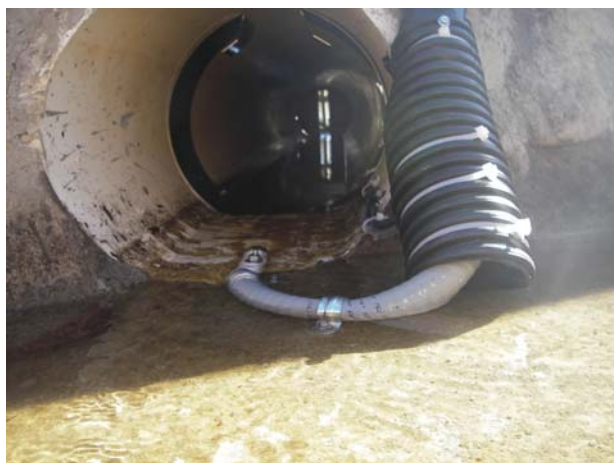
Effluent, After Equipment Installation

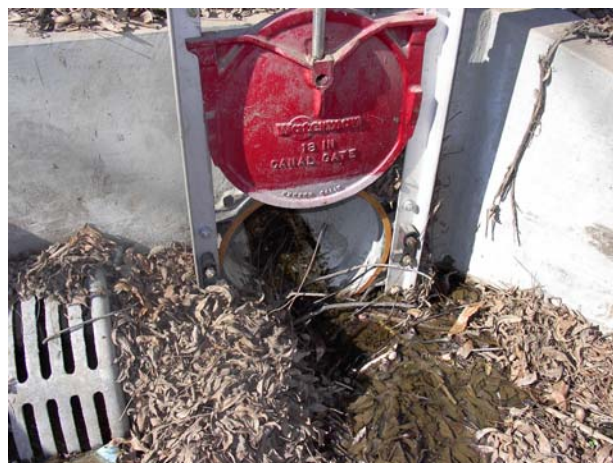
Effluent, Debris and Open Emergency Bypass
